**CARDIVNSWC-TR-61-95/12 June 1995**

**Interaction of Ship and Dock Cathodic Protection  
Systems Predicted From Potential Measurements of  
a Seawall at Panama City, Florida**

by  
Harvey P. Hack and Dana C. Lynn

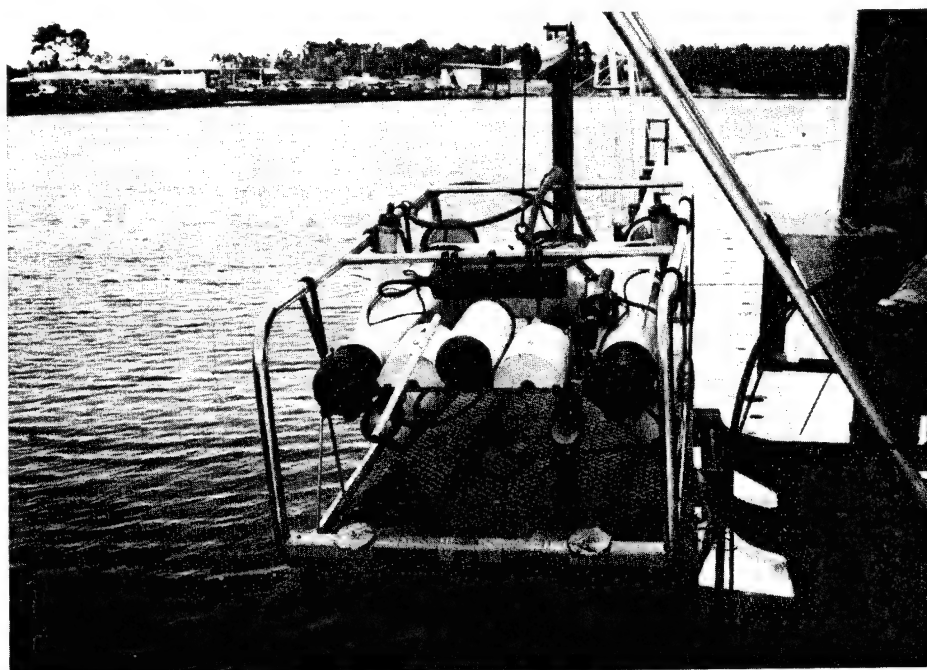
**Figure 3.** ROV used for potential measurements away from seawall.

The ROV was used as a platform for placing the reference cell accurately at positions far from the seawall. The ROV has the capability of going to any specified point in the water column and hovering there while measuring the potential. A photograph of the ROV is included as Figure 3. Attempts were made to match depths of these measurements with the dipping cell measurements next to the seawall, with the addition of another measurement near the bottom; however, tide variations made this matchup only approximate. The east corner of the east dock area was designated as the reference point for all measurements along the seawall, with the intersection of the east and south docks falling at roughly 200 m.
